Appendix 16-A: Traffic Evaluation, Cider Solar Farm

To:	Hecate Energy Cider Solar LLC	From:	Dan Quiri, PE Jon Hartley, PE
	Cider Solar Farm Towns of Oakfield and Elba Genesee County, New York		61 Commercial Street Suite 100 Rochester, NY 14614
File:	Traffic Evaluation	Date:	April 29, 2021

This memorandum provides a detailed technical traffic evaluation for the Cider Solar Farm located on approximately 4,650 acres of land in the Towns of Oakfield and Elba, Genesee County, New York.

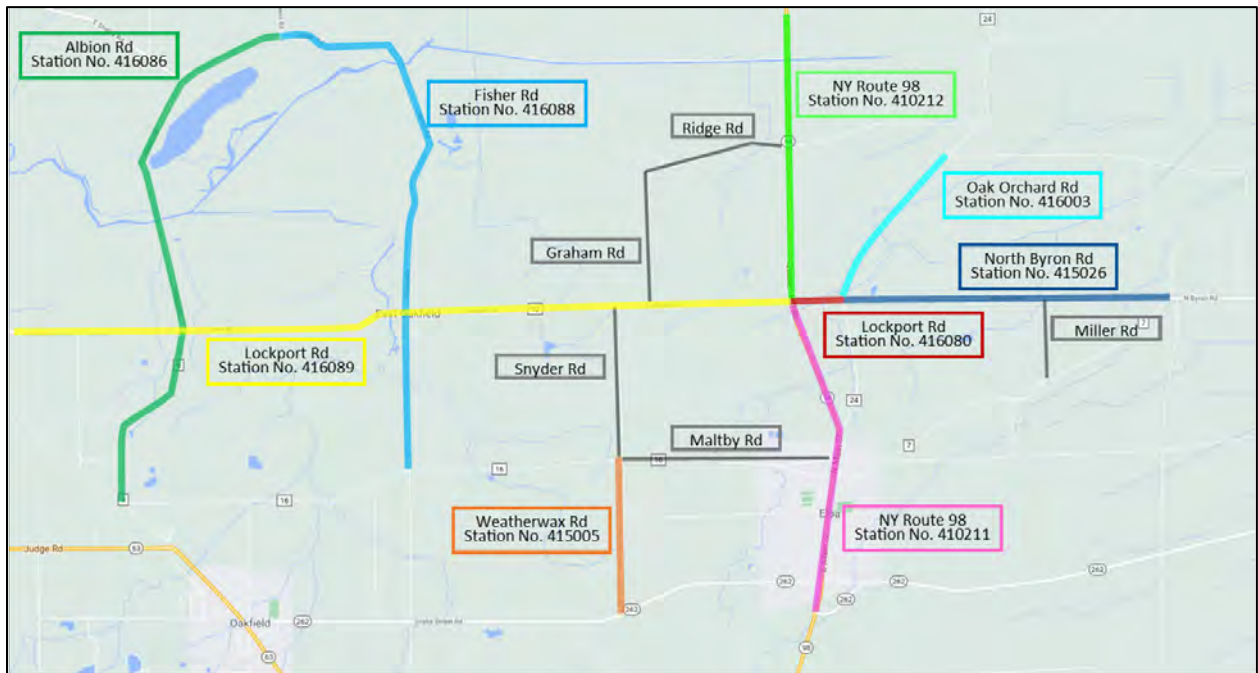
Existing traffic volume data was obtained from the New York State Department of Transportation (NYSDOT) traffic data viewer. A map of the available traffic data is shown below in Figure 1. It is noted that the study area roadways highlighted in grey do not have traffic data available for review and are all classified as local roadways. NYSDOT Traffic Volumes and Speed data sheets are included in Attachment B.

Figure-1: NYSDOT Traffic Data Viewer Locations

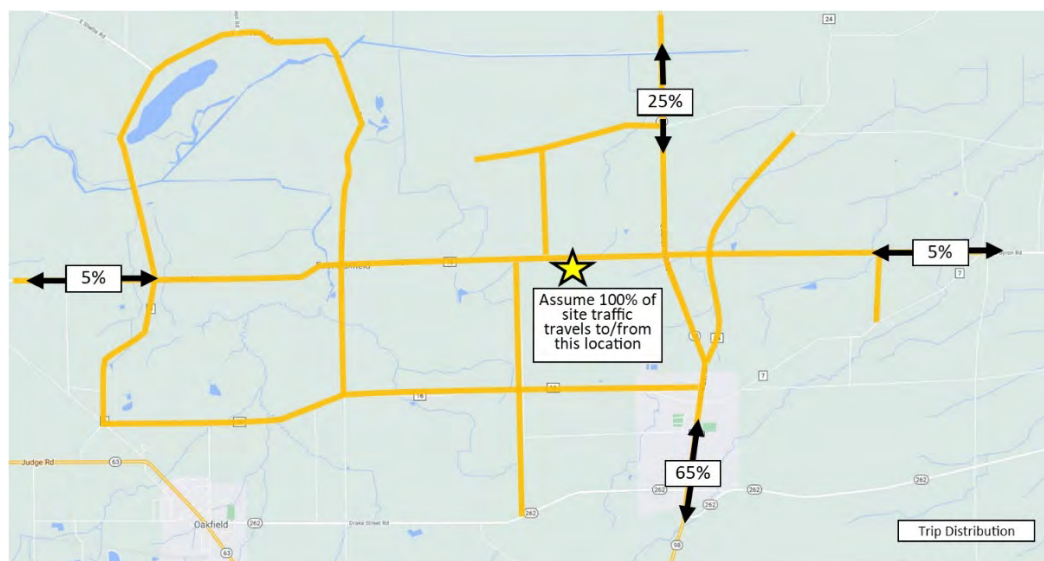
The directional distribution of traffic approaching and departing the Project Site is a function of several variables including population densities, existing travel patterns, and the efficiency of area roadways. Based on a review of the existing travel patterns, surrounding roadway network, and population centers in the area it is estimated that 65% of the construction traffic will travel to and from the site via the south on NY Route 98 and 25% will travel to and from the north on NY Route 98. It was assumed that 5% of the traffic will travel to and from the east and west via Lockport Road and North Byron Road. It is noted that all traffic was assumed to enter/exit one driveway location off Lockport Road to provide for the worst-case scenario, although 26 driveways are proposed throughout the study area. It is noted that the internal earthwork trips were all assigned to Lockport and North Byron Road to provide for a conservative analysis. Figure 2 shows the estimated trip distribution for construction vehicles to access the site.

Figure 2: Trip Distribution

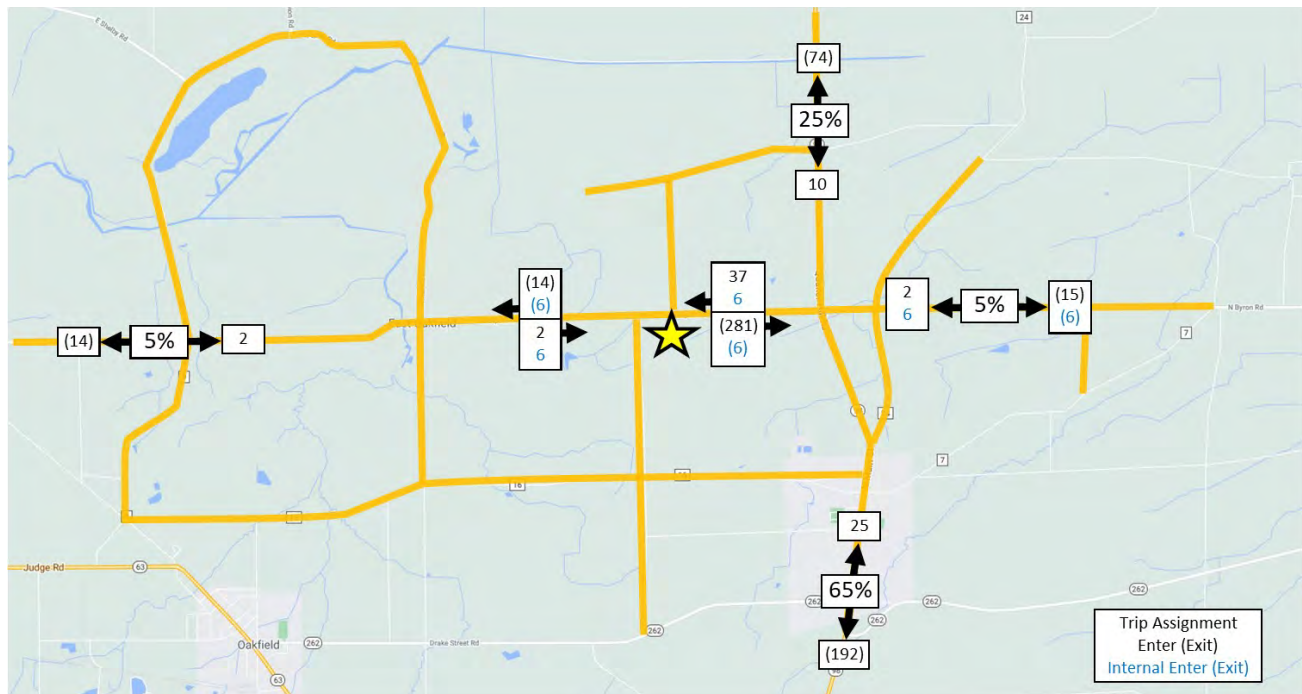
The PM peak hour site generated construction traffic volumes were assigned to the roadway network according to the distribution and travel patterns described above and are shown below in Figure 3. Trip assignment volumes were then added to the existing PM peak hour volumes used from the NYSDOT Automatic Traffic Recorder to obtain the construction peak traffic.

Figure 2: Trip Assignment

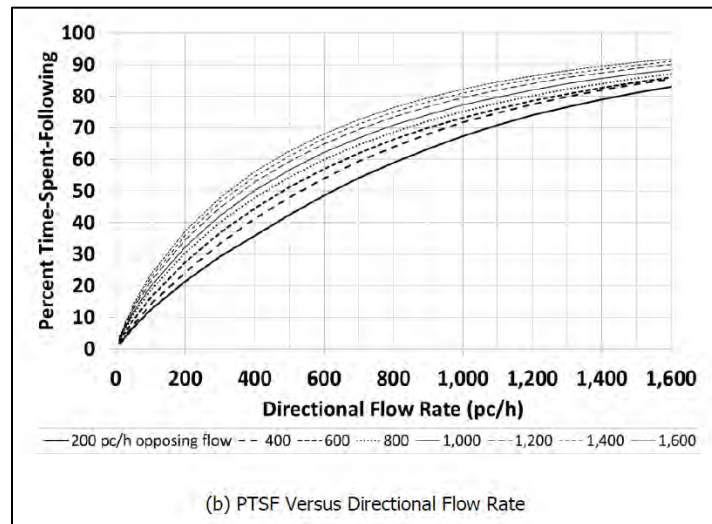
The percent follower in the analysis direction was determined using Exhibit 15-2 in the Highway Capacity Manual which compares the directional flow rate of traffic to the percent time spent following, as shown in Figure 4.

Figure 3: Exhibit 15-2 from the Highway Capacity Manual, Page 15-7; Percent Time Spent Following Versus Directional Flow Rate

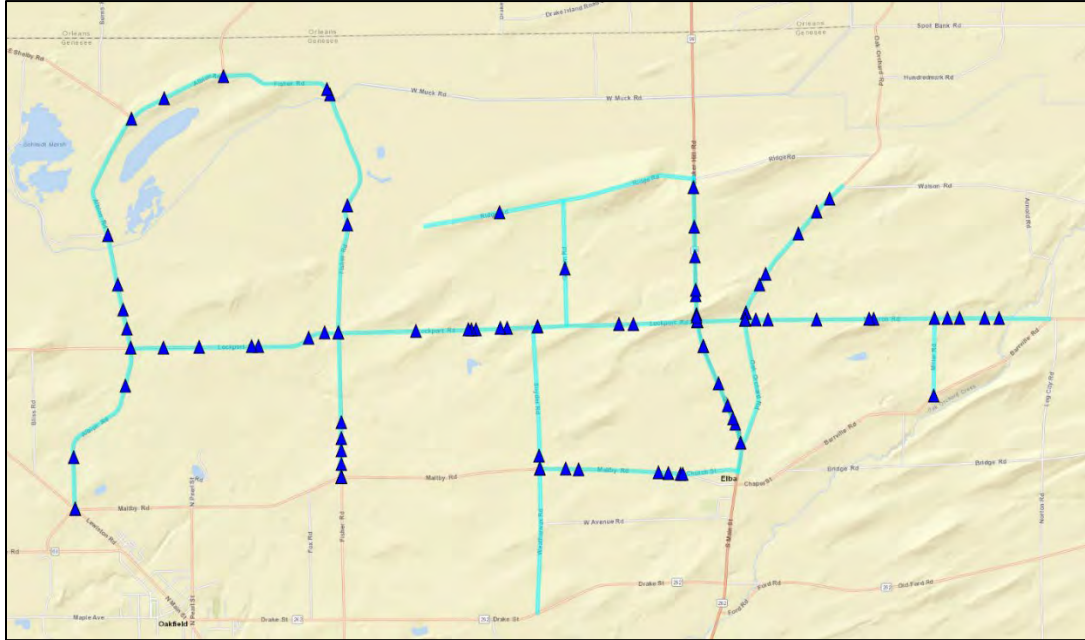
Figure 4: Study Area Crash Locations

Existing accident data for the Project Area was obtained from NYSDOT for the latest three-year period ranging from October 31, 2017 through October 31, 2020. During the three-year period, there were a total of 108 documented accidents with the main apparent factor being related to hitting a deer or animal resulting in 45% of the crashes (49 total accidents). Most non-animal related crashes occurred due to driver error such as failure to yield to the right-of-way (16), unsafe speed (10), unsafe lane change (5), alcohol involvement (3), backing unsafely (1), driver inattention (3), fatigued/drowsy (1), following too closely (1), obstruction/debris (2), oversized vehicle (1), passenger distraction (1), passing or improper lane usage (2), slippery pavement (3), pedestrian error (1), traffic control devices disregarded (2), turning improper (2), and view obstructed/limited (1). It is noted that one crash involved a motorist striking a bicyclist on a dark, unlit roadway.

It is noted that six (6) of the 16 failure to yield to the right-of-way crashes occurred at the intersection of Lockport Road and Quaker Hill Road (NY Route 98), three (3) occurred at the intersection of Fisher Road and Maltby Road, two (2) occurred at the intersection of Oak Orchard Road and North Byron Road, and the remaining five (5) occurred at various intersections. The data was analyzed to determine if there were any patterns causing the failure to yield crashes and it was found that lighting conditions were not a factor as only two (2) of the 16 crashes occurred on a dark, unlit roadway. Weather conditions were also studied and noted to not be an apparent factor. Nine (9) crashes occurred on a dry road, five (5) occurred on a wet road, and the remaining two (2) occurred in snowy/icy road conditions.

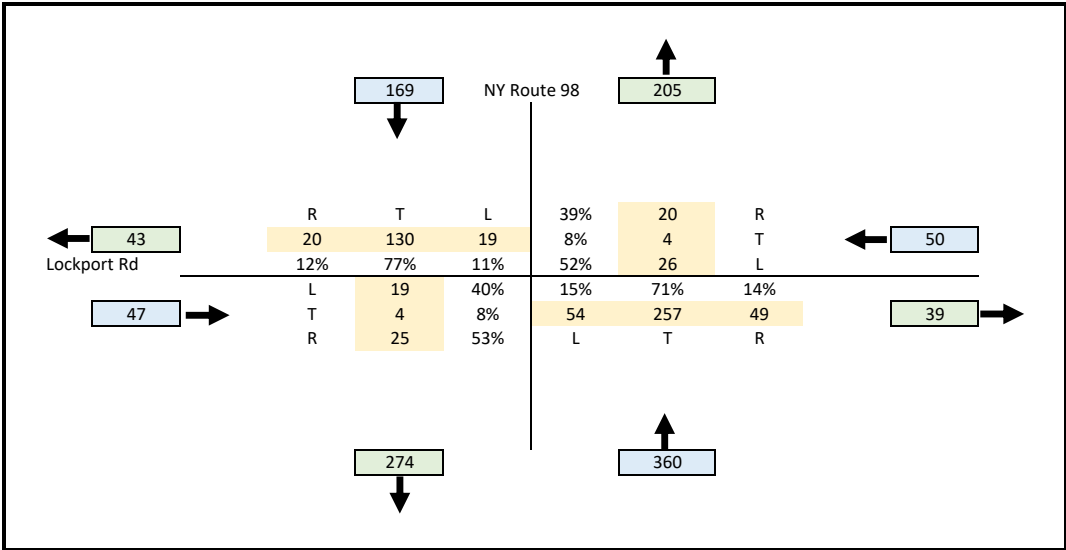
Existing PM

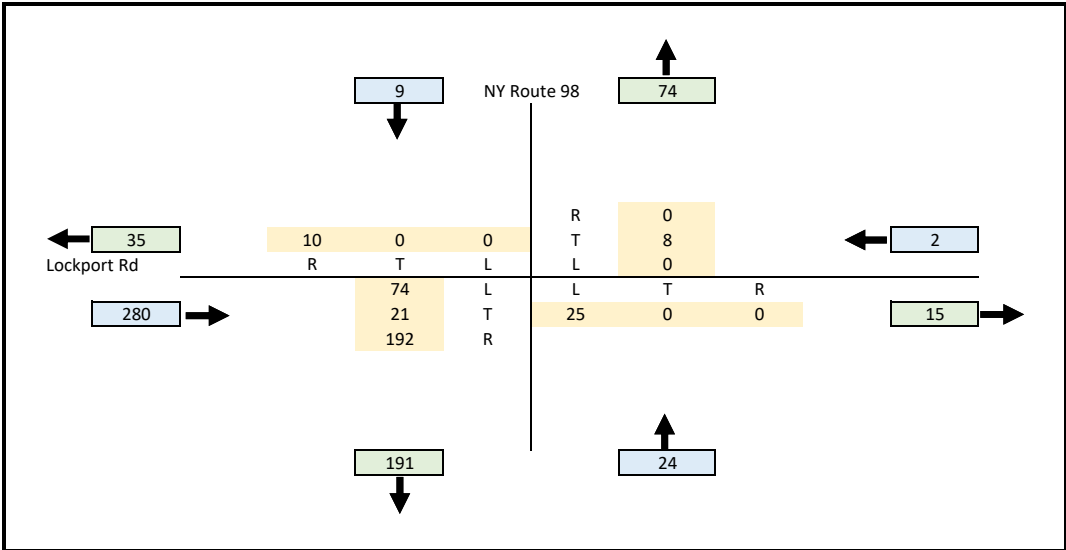
Trip Assignment

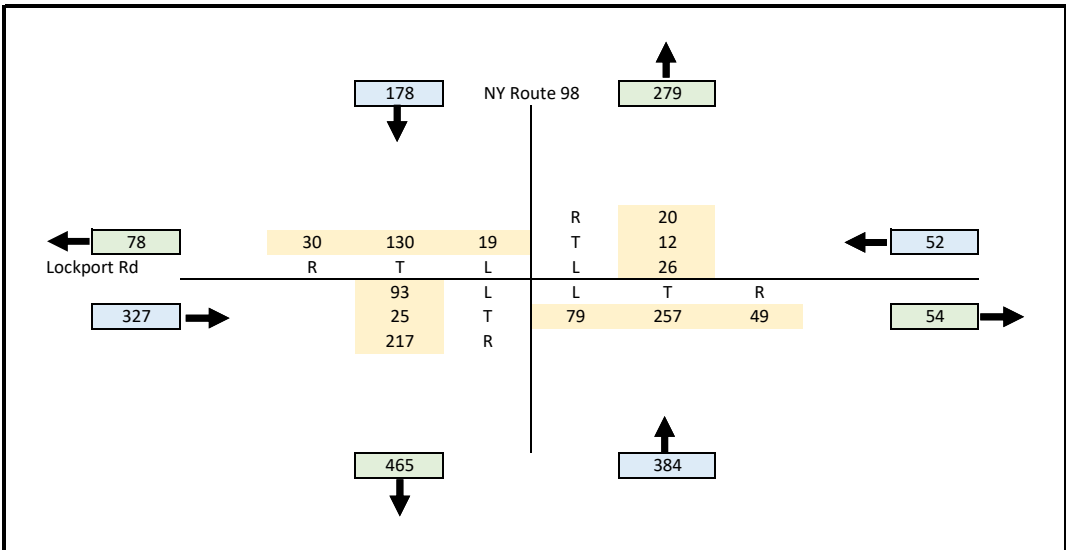
Peak Construction - PM Peak
